Manhole Inspection Summary

Manhole # S11O__022MH

Location Address: **3130 Frederick Ave**

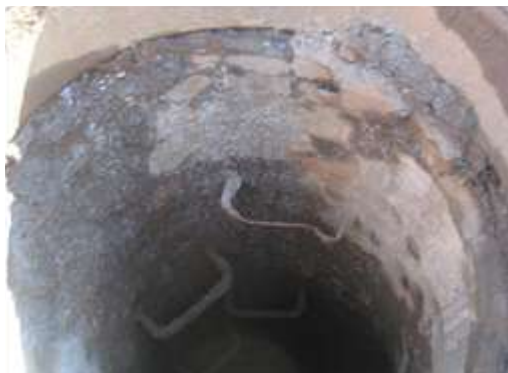
Defect 4

Infiltration at chimney and corbel

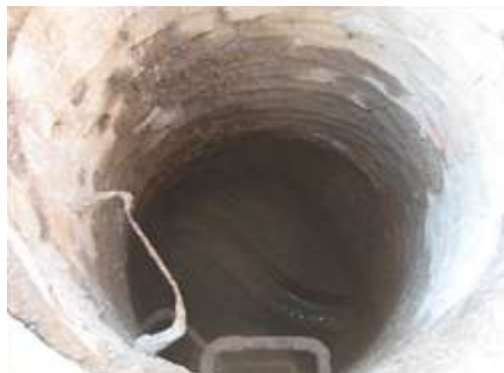
Defect 6

infiltration along corbell and wall

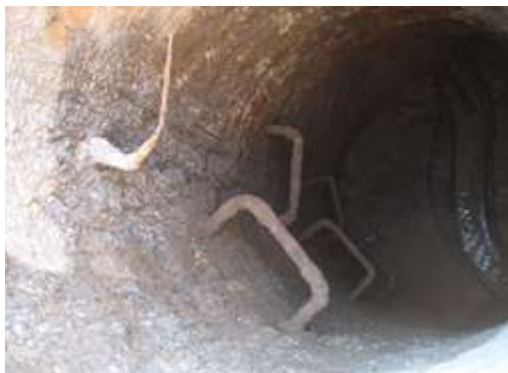
Defect 2

Corroded steps and barrel infiltration

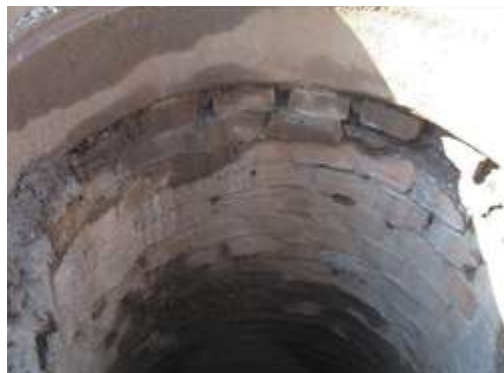
Defect 1

Loose bricks and mortar under frame/corbel and barrel infiltration

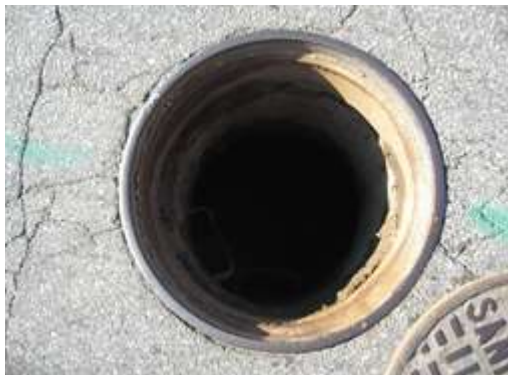
Defect 3

frame leaks

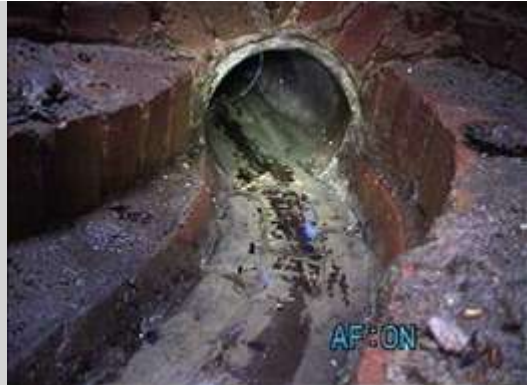
12 O'Clock Outflow

Pipe Height: **8.4** (in.) Rod and Bar (Angled)
Pipe Material: **Clay** ☐ Pipe Lined
Invert Depth: **11.20** (ft.) Flow Characteristics: **Fast**
Deposits: ☒ None ☐ Mud ☐ Sludge ☐ Debris ☐ Grease
Silt Depth: **0** (in.) Deposits Extent:
Infiltration: **None** Pipe Seal Cond: **Sound**

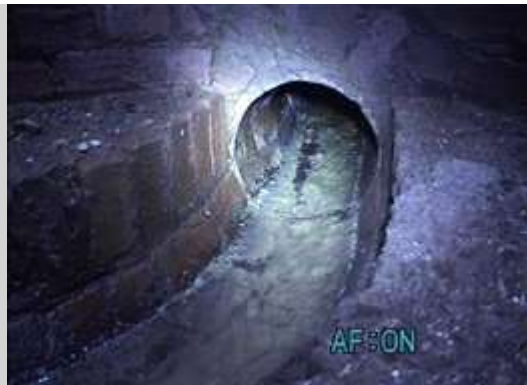
6 O'Clock Inflow

Pipe Height: **8.4** (in.) Rod and Bar (Angled)
Pipe Material: **Clay** ☐ Pipe Lined
Invert Depth: **11.07** (ft.) Flow Characteristics: **Fast**
Deposits: ☒ None ☐ Mud ☐ Sludge ☐ Debris ☐ Grease
Silt Depth: **0** (in.) Deposits Extent:
Infiltration: **None** Pipe Seal Cond: **Sound**
